Baytowne Homeowners Association
c/o Messler & Associates, Inc.
7741 North Military Trail, Suite 5
Palm Beach Gardens, Florida 33410

**ADDITIONAL PAVEMENT INVESTIGATION
BAY STREET PAVEMENT IMPROVEMENTS - BAYTOWNE @ JONATHAN'S LANDING
JUPITER, FLORIDA**

TEST LOCATION PLAN

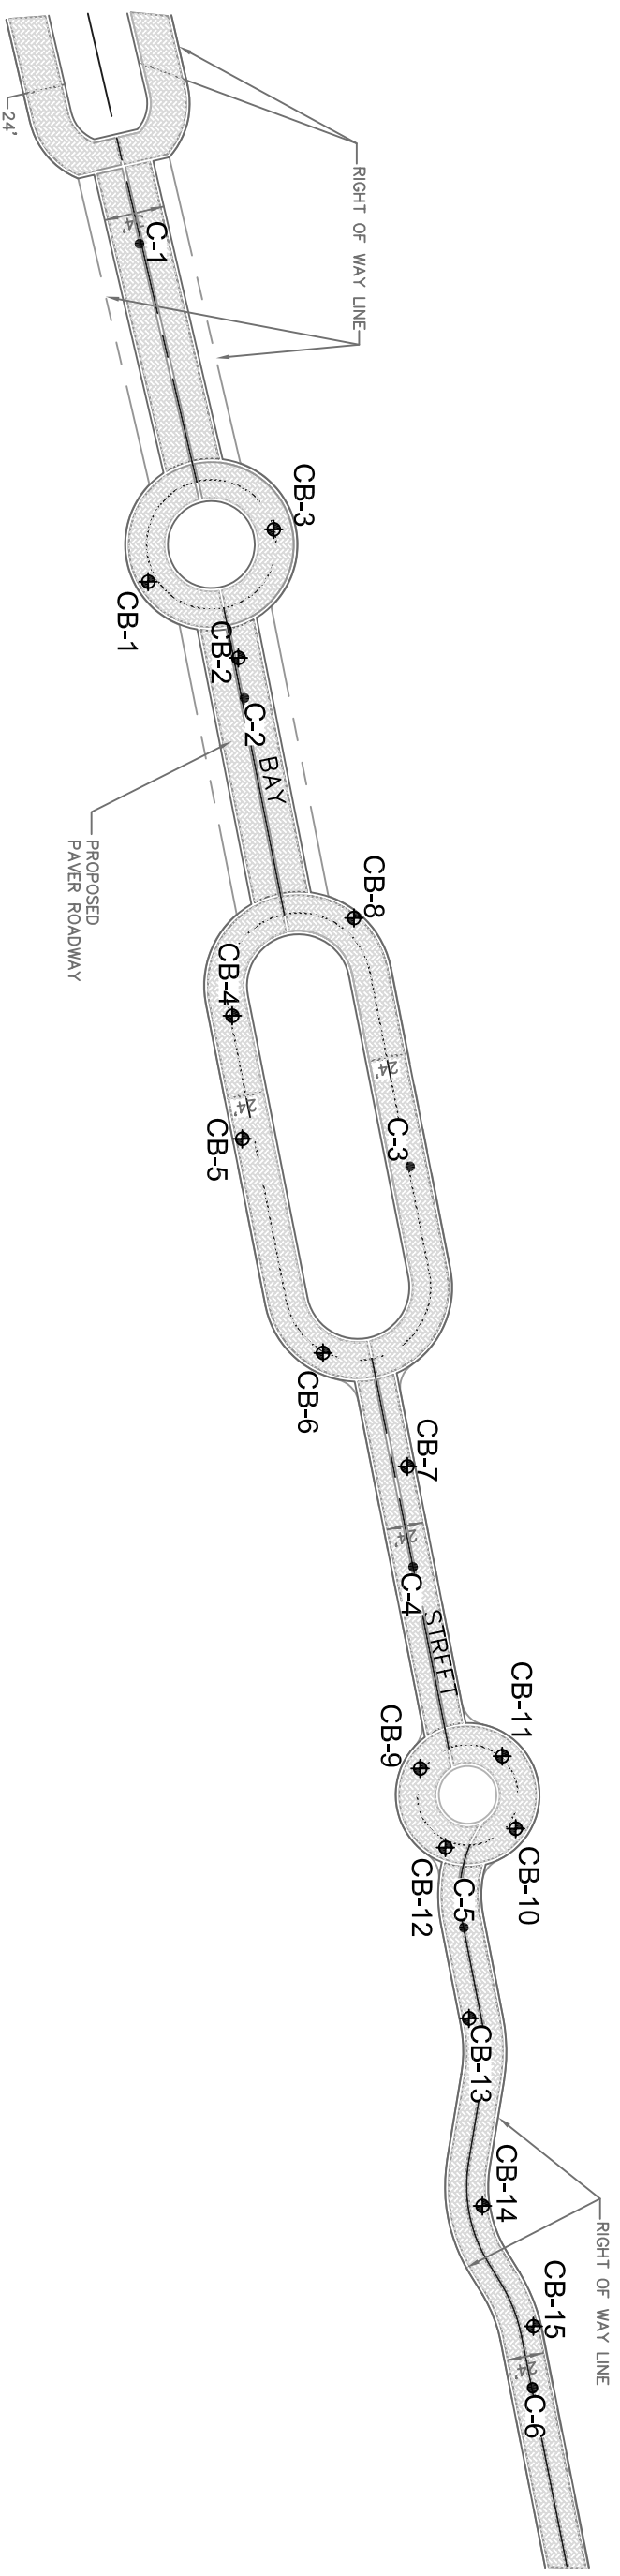
On December 3 and 4, 2007, representatives of our Firm cored holes through the concrete pavement at sixteen (16) additional locations along Bay Street, the approximate test locations are shown on Figure 1. Auger borings were performed through the core holes using a portable bucket auger to explore the shallow soils beneath the pavement. The hand auger borings were terminated at depths ranging from 4 to 10 feet below the pavement surface. The thickness of the concrete pavement, shallow subsurface profile and groundwater depth at each test location are presented in the attached core boring logs. In general, the concrete pavement ranges from 3.75 to 6 inches in thickness, with an average of 4.8 inches; and is underlain by 8 to 12 inches of brown fine sand with small rock and shell fragments, followed by brown and gray fine sands reaching the termination depths of our borings. Our boring CB-5, performed along the east side of the pool, encountered a layer of soft fibrous organics (peat) approximately 3 feet in thickness, starting at a depth of 6 feet below the pavement surface. In addition, our borings CB-9 and CB-11, performed within the southern half of the northern roundabout, encountered obstructions at depths of 6 to 6.5

feet, respectively, which could not be penetrated using our portable hand augering equipment; these obstructions appeared to be large wood pieces. It is likely that the peat layer found at the location of our boring CB-5 is present at other locations beneath the termination depths of our borings; particularly in the area of borings CB-9 and CB-11 where the encountered obstructions are likely large wood pieces at the top of the organic layer.

Based on the findings of our pavement investigation program, it is our opinion that the presence of organic soils beneath portions of the existing roadway likely contributed to the deterioration of the concrete pavement which is inherently susceptible to cracking damage resulting from ground settlement resulting from the consolidation/decomposition of the organic soils.

The approximately 8 to 12-inch thick layer of brown fine sand with small rock and shell fragments present directly beneath the existing concrete pavement does not appear to have sufficient stability for consideration as future pavement base material. Consequently, after removing the existing concrete pavement, the exposed surface will have to be cut as needed to accommodate a 4-inch layer of imported base material. The base material should consist of approved crushed limerock. Alternatively, consideration can be given to the use of a concrete reclamation procedure to crush the existing concrete pavement and subsequently use it as base material for the new pavement, thus avoiding the cost associated with its disposal. In any case, the base material should be well graded and should have a Limerock Bearing Ratio (LBR) value in excess of 100.

Once the pavement areas have been cut to the elevation of the bottom of the base course, the exposed surface should be compacted with a heavy vibratory roller so as to produce minimum dry densities of 98 percent of the Modified Proctor (ASTM D-1557 / AASHTO T-180) maximum dry density value of the subgrade soils to depths of 1 foot below the compacted surface. The base course can then be placed in a single lift, compacted with a vibratory roller to a minimum dry density of 98 percent of its Modified Proctor maximum dry density value. Subsequently, the interlocking concrete paver stones are to be placed atop a 1-inch layer of bedding sand, with their joints filled with sands. The pavement surface should be vibrated with a suitable vibratory plate compactor to properly set the pavers.
