Baytowne Homeowners Association
c/o Messler & Associates, Inc.
7741 North Military Trail, Suite 5
Palm Beach Gardens, Florida 33410

**ADDITIONAL PAVEMENT INVESTIGATION
BAY STREET PAVEMENT IMPROVEMENTS - BAYTOWNE @ JONATHAN'S LANDING
JUPITER, FLORIDA**

TEST LOCATION PLAN

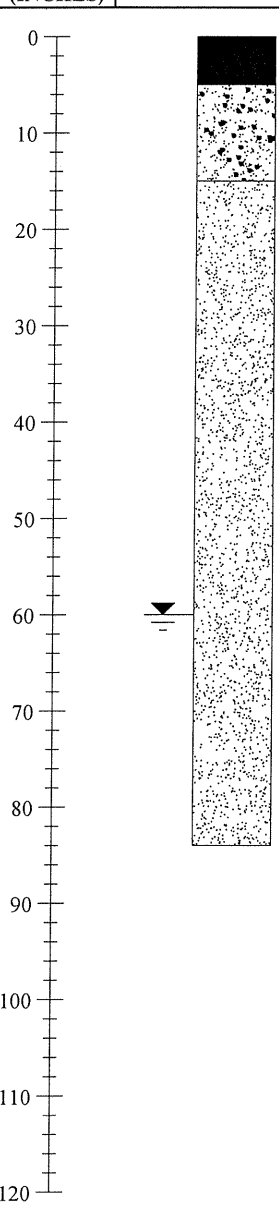
WATER OBSERVED AT DEPTH 60 inches

Concrete (5")	
10		Brown fine sand with shell and rock fragments (10")	
20		Light brown fine sand	
30			
40			
50			
60			
70			
80			
90			
100			
110			
120

NOTES: Boring terminated at a depth of 7 feet below the pavement surface
